## Case Study

### Oil Analysis prevents Major Engine Failure on the YWAM Medical Ship

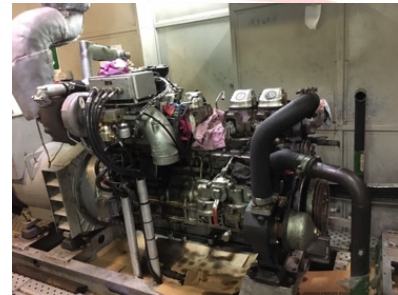
Oil Laboratories - PNG have been carrying out routine oil analysis and diagnostics on machinery onboard the YWAM PNG for the past 8 months. During the first 5 months the samples reported results within normal operating limits. During this period, we took the opportunity to establish the safe running hours for the main engine oil by monitoring the key properties of the oil, Viscosity, Oxidation Soot and TBN. As the operating hours of the oil increase the additives in the oil are depleted and the values of the key properties change. The viscosity starts to increase along with soot and oxidation levels, at the same time the TBN slowly decreases. This work allowed us to establish that under normal operating condition the oil currently used in the main engine has a safe working life of 700 hours and should be changed before 800 hours.

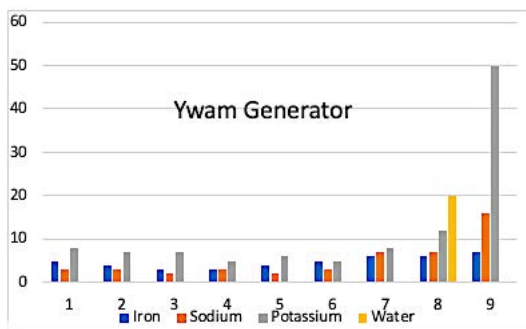
However, the eight-month sample reported a slight increase in iron but a significant jump in sodium

and potassium, plus water was present in the oil this was enough evidence to warrant raising a caution warning. With a request for the engineers to inspect the engine for an internal coolant leak. *Sodium and Potassium are elements found in the cooling water anti-corrosion additives, when found in the engine oil they indicate there could be a coolant leak into the engine. But at the level we found these elements it would be weep rather than a leak.*

As this was the first indication of a leak, the engine was operating without a problem and inspecting for a leak is a rather large and onerous task, the engineers decided to keep operating the engine but monitor it closely.

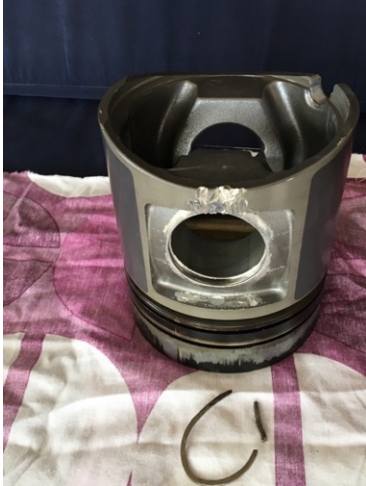
However, on the nine-month sample water was not detected in the sample but the Sodium and Potassium in the oil raced past the critical level indicating the leak was accelerating. The laboratory staff immediately contacted the staff on the YWAM recommending an immediate inspection of the engine.

*A point of interest, it is not unusual for water not to be detected in the oil of an engine with a slow coolant leak. As most of the water will evaporate from the hot engine oil, the remainder will dissolve into the oil. Only the more sophisticated analysis techniques will identify dissolved water in oil, and these are not usually carried out routinely as these analyses are time consuming and expensive.*

The YWAM engineers stopped the starboard generator drained the oil and removed the sump. They then pressurised the cooling circuit monitoring the system for a slow pressure drop while inspecting the lower lip of the cylinder liners. Sure enough, number 3 cylinder showed a drip of water indicating a slow leak.

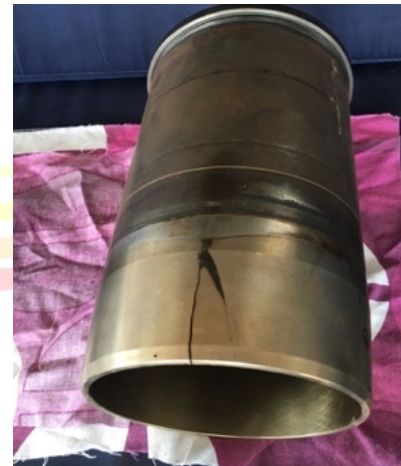
They then removed the head and piston and found that the circlip retaining the gudgeon pin had broken and dropped out working its way past the piston down the liner into the sump. During the transit it had scoured the skirt of the piston and cracked the liner, but the engine remained operational. However, water was now weeping through the cracked liner into the oil.

If this problem had not been picked up by oil analysis and if the YWAM engineers had not acted so promptly, there is a distinct possibility that cylinder 3, may have hydrolocked. Subsequently bending the connecting rod, and either bending or breaking the crankshaft, putting the vital generator out of action necessitating major repairs or engine replacement

In this instance the repairs were relatively simple: a replacement piston, rings, circlips and liner plus associate gaskets engine fluids and labour then the engine will be operational once more.
